VIDEO INSPECTION REPORT

| PROJECT: Harris County WCID 99 | | AREA: 210 Bickett Lane | | DATA MANAGEMENT INFORMATION | | | |

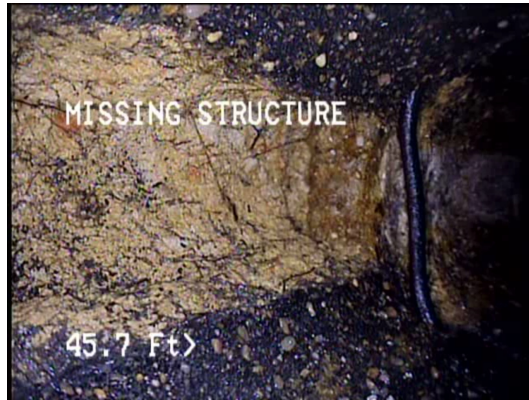
45.7 STATION DEFECT

| STA. D | STA. R | 🕒 | Observations | Struc. Tap | Struc. Def. | Obs. Def. | Joint Def. | Align. | I & I | Det. |
|---|---|---|---|---|---|---|---|---|---|---|
| 45.7 | | 12 | Pipe Missing, 25% to 50% | | 10 | | | | | |

Pipe Missing, 25% to 50%

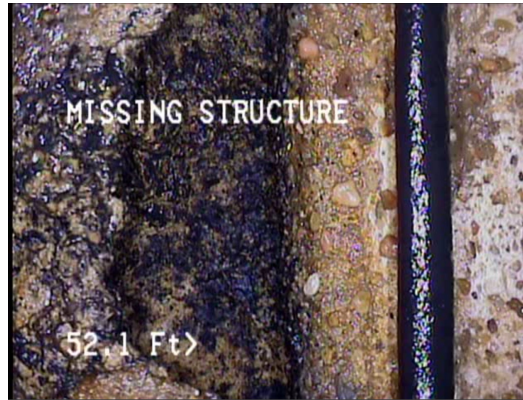
52.1 STATION DEFECT

| STA. D | STA. R | 🕒 | Observations | Struc. Tap | Struc. Def. | Obs. Def. | Joint Def. | Align. | I & I | Det. |
|---|---|---|---|---|---|---|---|---|---|---|
| 52.0 | | 12 | Joint Defect-Gasket Pipe Missing,<25% | | | 10 | 2 | | | 2 |

Pipe Missing, <25%
Joint Defect-Gasket

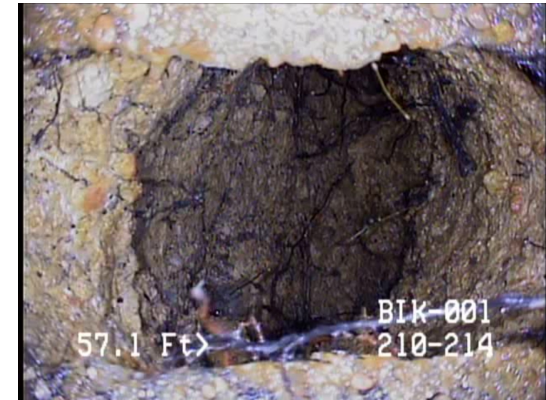
57.1 STATION DEFECT

| STA. D | STA. R | 🕒 | Observations | Struc. Tap | Struc. Def. | Obs. Def. | Joint Def. | Align. | I & I | Det. |
|---|---|---|---|---|---|---|---|---|---|---|
| 57.1 | | 12 | Pipe Missing, 25% to 50% Deterioration-Heavy | | 10 | | | | | 3 |

Extremely Heavy Deterioration

Hole in structure
Heavy deterioration
