VIDEO INSPECTION REPORT

PROJECT: Harris County WCID 99		AREA: 210 Bickett Lane		DATA MANAGEMENT INFORMATION			
				Disc Number	BIK-001	Report Date	10/29/2019
				Segment File No.	BIK001.2	TV Date	10/24/2019
				Report File No.	BIK001.2	TV Tech	TJ
				Project Operator	Eagle Water Mgmt.		
				Project Engineer			
Line Segment Information				LINE SEGMENT and PIPE INFORMATION			
Up Stream Manhole		Down Stream Manhole		Tv Distance	61.0	Pipe Type	Concrete
214		218		Pipe Diameter	10.0"	Line Number	
Actual Distance		61.0		Line Depth	6.50'	Easement	Street ROW

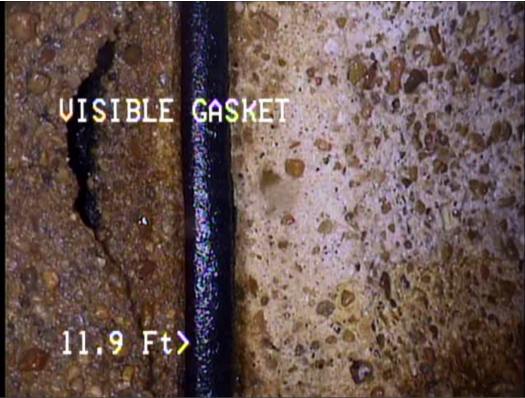
11.9 Station Defect
Joint Defect-Gasket
Deterioration

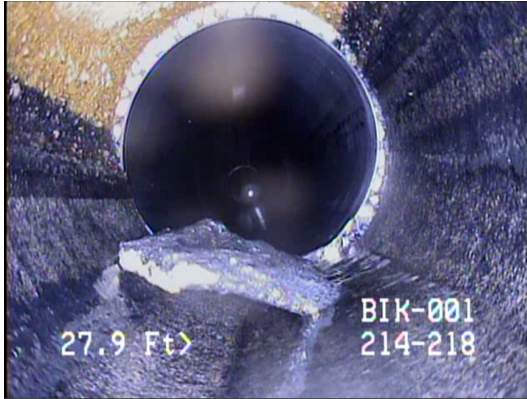
29.8 Station Defect

Transition from concrete to ABS
Joint Offset-Slight

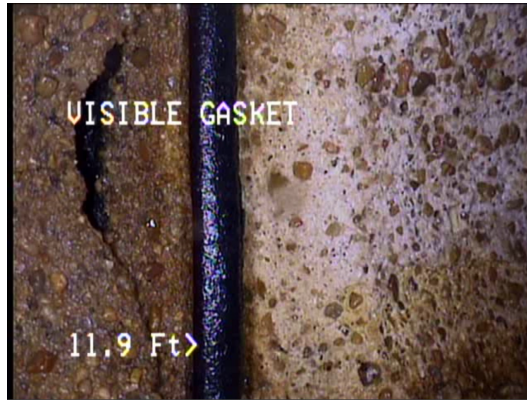
11.9 STATION DEFECT

Joint Defect-Gasket

Deterioration

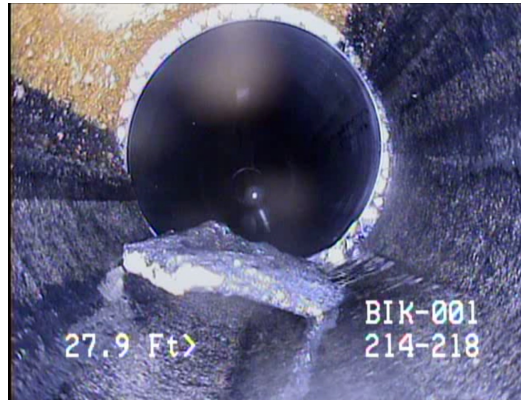
29.8 STATION DEFECT

Transition from concrete to ABS
Joint Offset-Slight
