VIDEO INSPECTION REPORT

PROJECT: Harris County WCID 99		AREA: 210 Bickett Lane		DATA MANAGEMENT INFORMATION			
				Disc Number	BIK-001	Report Date	10/29/2019
				Segment File No.	BIK001.1 .mp4	TV Date	10/24/2019
				Report File No.	BIK001.1 .pdf	TV Tech	TJ
				Project Operator	Eagle Water Mgmt.		
				Project Engineer			
Line Segment Information				LINE SEGMENT and PIPE INFORMATION			
Up Stream Manhole		Down Stream Manhole		Tv Distance	57.0	Pipe Type	Concrete
218		222		Pipe Diameter	10.0"	Line Number	
Actual Distance		62.0		Line Depth	7.25'	Easement	Street ROW
UpStream Manhole Address:		DownStream Manhole Address:		Estimated Connections	>100	Line Class	Main Line
218 Bickett Lane		222 Bickett Lane		TEST CONDITIONS			
Ups MH Type		Dwn MH Type		Inspection Format	Evaluation Survey-Sanitary Sewer		
PRE-CAST		PRE-CAST		Camera Direction	Downstream	Line Status	Live, "in-service"
Condition		Condition		Dye Test	N/A	Dye Test Result	N/A
Average		Average

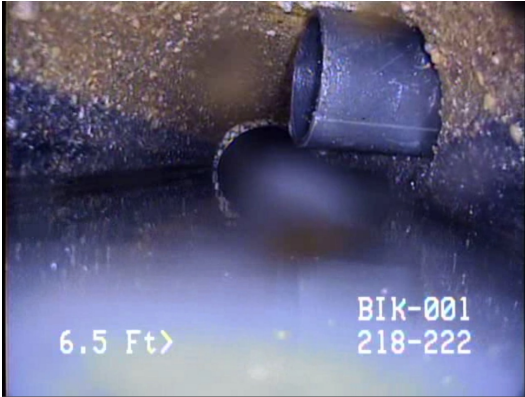
8.3 Station Defect
Protruding Service, 25% to 50%

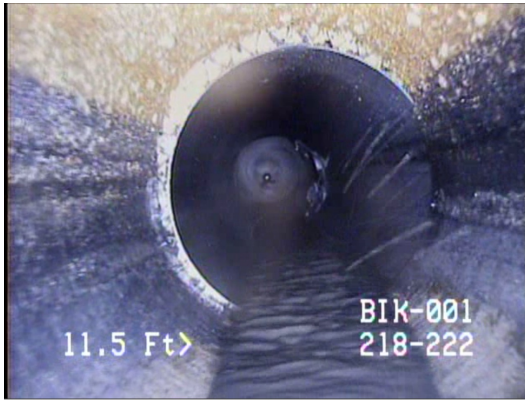
12.0 Station Defect

Transition from concrete to ABS

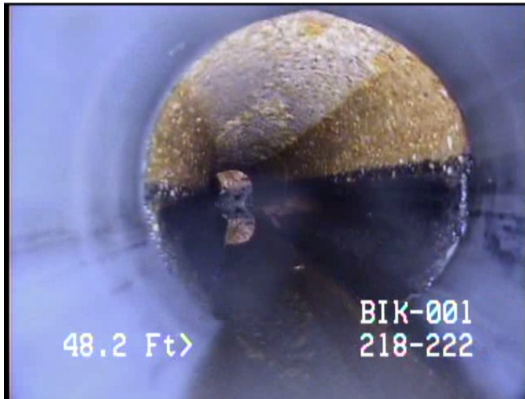
50.0 Station Defect

Transition to Concrete

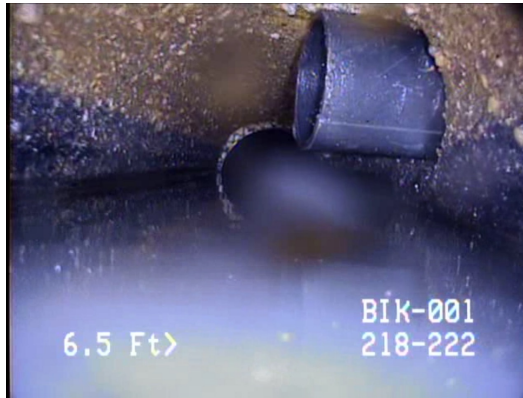
8.3 STATION DEFECT
Protruding Service, 25% to 50%

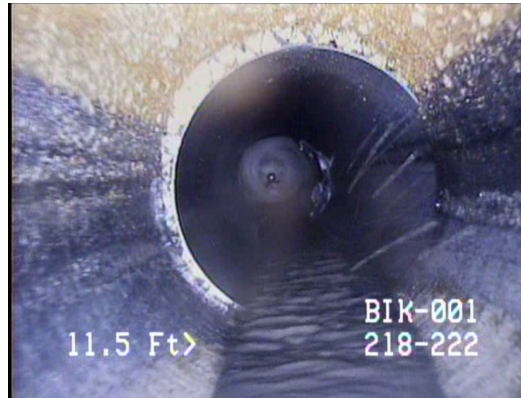
12.0 STATION DEFECT
Transition from concrete to ABS

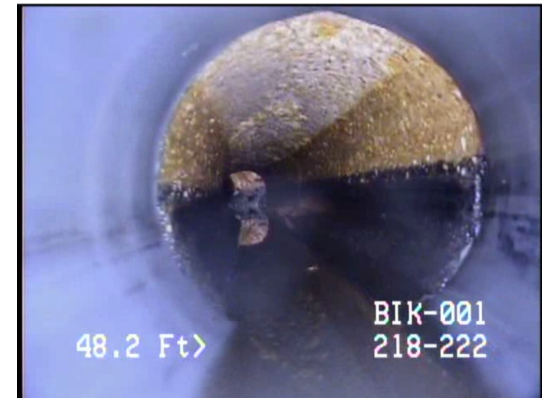
50.0 STATION DEFECT
Transition to Concrete
